Evaluation of the Three-year Experience with All-ceramic Crowns with Polycrystalline Ceramic Cores

Vavřičková L.¹, Dostálová T.², Charvát J.³, Bartoňová M.³

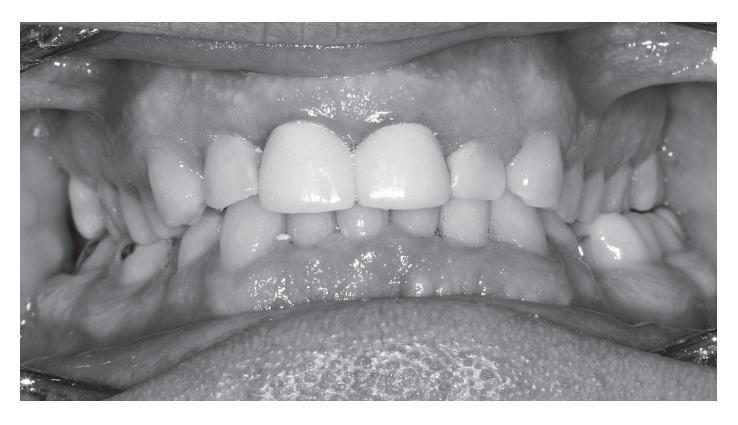
Figure 1 – Patient before treatment from frontal view.

Prior to the preparation of the tooth for an all-ceramic crown, an impression was made using an alginate impression material (Tropicalgin, Zhermack[®], Italy) for provisional crowns fabricated by swaging (Protemp II, 3M Espe, USA, Luxatemp, DMG, Germany). The two independent operators performed the treatment. They were calibrated with regard to preparational guidelines (Figures 1 and 2).

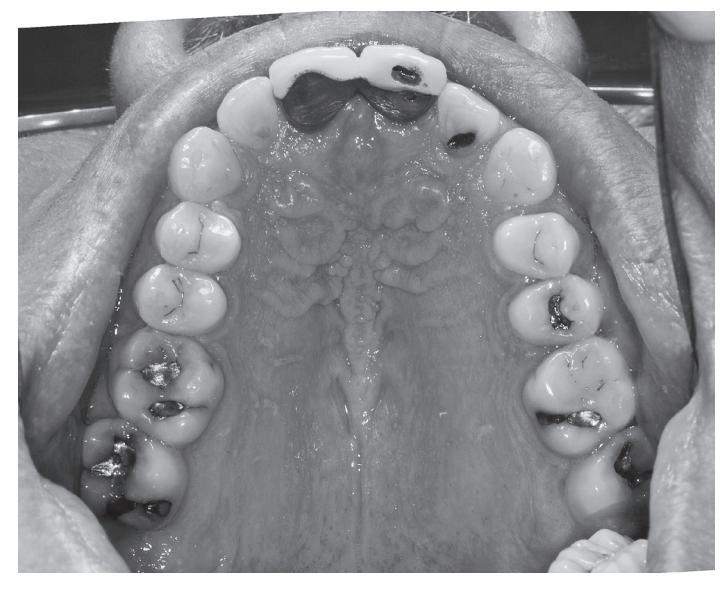
Figure 2 – Patient before therapy from palatal view.

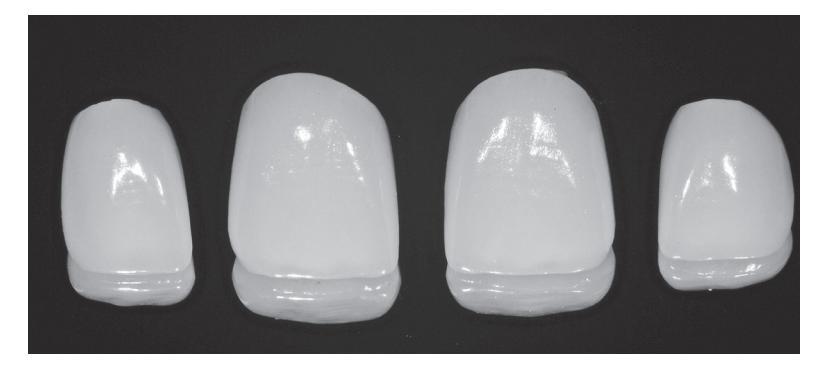
Figure 3 – All-ceramic crowns before insertion.

Initially the received crown cores were assessed for fit and adapted to the prepared tooth abutment. During continuous cooperation with the dental laboratory, the entire crown was inspected in the bisque state. After the high-precision articulation and inspection of the marginal seal, contact points, fitting of the crown and overall aesthetics, the crown was sent to the laboratory for glazing and finishing (Figure 3).

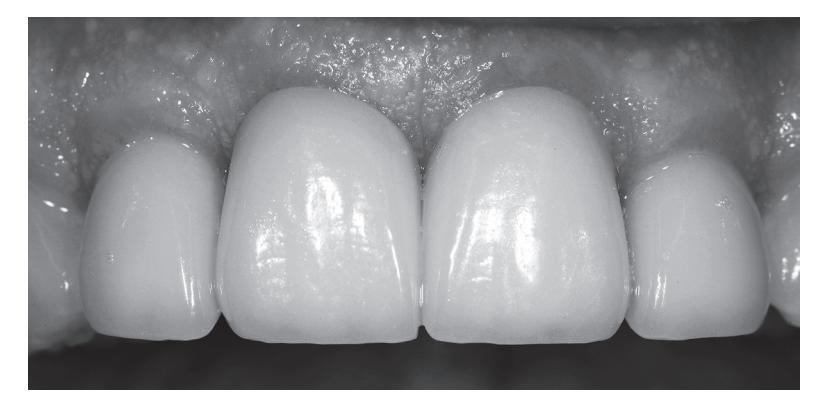
Figure 4 – All-ceramic crowns (all upper incisors) in situ.

The final luting of the crown was achieved with a self adhesive, resin cement or glass-ionomer cement (Fuji Plus, GC Corp., Japan, or RelyX Luting Plus Cement, 3M Espe, USA). As these are non-etchable ceramics, their superficial internal microscopic surface treatment ensures reasonable cement adhesion in clinical terms (Figure 4).

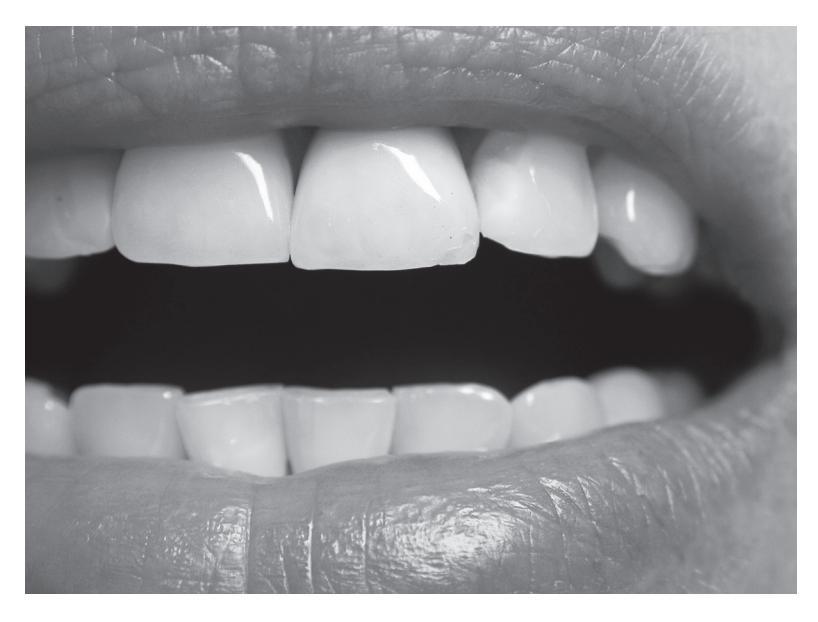
Figure 5 – Chipping of left upper central incisor.

was treated by composite resin restorations in the past. Radiographic evaluation revealed a periapical lesion in the second maxillary premolar, which was also treated endodontically (gutta percha with vertical condensation). In these cases, we performed trephination was performed through the crowns and after endodontic treatment the access was restored with a composite resin material. Both crowns are still present in the patients' mouths. In five crowns, the chipping of veneering ceramics was observed. Two of these were made smooth, polished and are remaining well in function. Both cases involved central upper incisors. Three crowns were fabricated again as new crowns, of which 2 had chipped veneering ceramics (Figure 5) and one also had a fractured zirconia core (Cercon[®], Dentsply Ceramco, USA). These crowns were cemented to a maxillary lateral incisor, maxillary canine, and first maxillary premolar. Chipping of the ceramics (including the core fracture) required replacement which occurred 8 weeks after the cementation. All failed crowns had a zirconia core (Cercon[®], Dentsply Ceramco, USA) and were cemented with resin reinforced glass ionomer cement (Rely X Luting cement, 3M Espe, USA). This failure occurred in a patient with bruxism and an increased attrition of the teeth before the treatment.

Clinical outcomes seem to be very favourable so far. Interestingly a ceramic chipping (failure of the work) requiring crown replacement occurred in 3 crowns with zirconium oxide cores in a patient with increased wear of the teeth (bruxism).
